## MEMS reliability in a vibration environment

Danelle M. Tanner, Jeremy A. Walraven, Karen S. Helgesen, Lloyd W. Irwin,  
Danny L. Gregory, John R. Stake, and Norman F. Smith

Sandia National Laboratories, P.O. Box 5800, MS 1081, Albuquerque, NM 87185-1081  
<http://www.mdl.sandia.gov/Micromachine>  
email: [tannerdm@sandia.gov](mailto:tannerdm@sandia.gov)

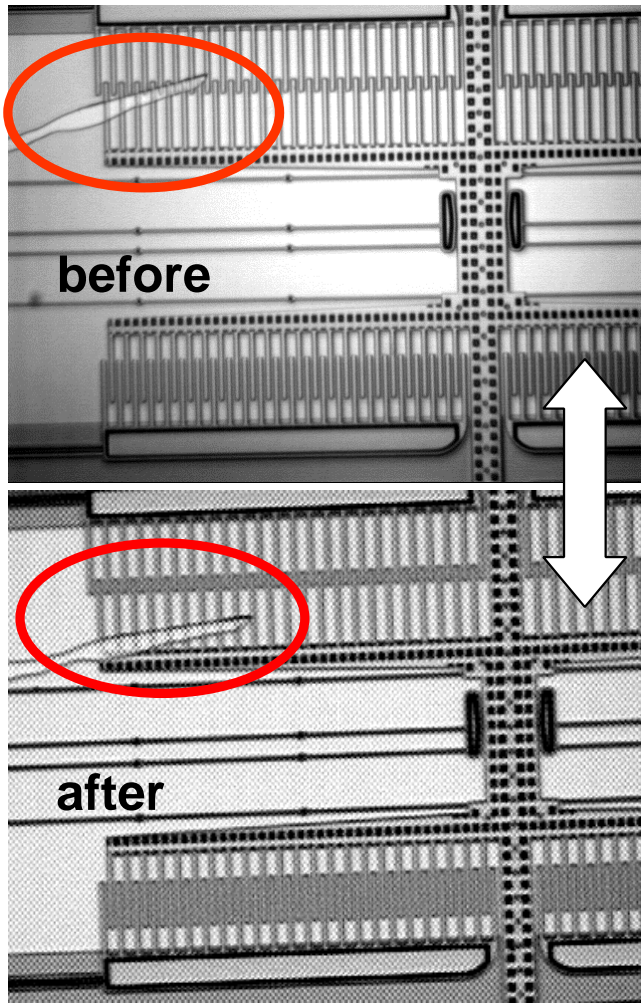
The initial test was highly successful with 13 out of 14 microengines surviving and functioning at the 1 Hz inspection speed with no observable damage. We observed no stiction or misalignment problems in the microengines tested in the top/bottom orientation. The only overall effect noticed after vibration was a small change in the location of debris along the surface of the packaged die. Figure 7 shows the before and after images of debris movement. The vibration direction was long side as indicated in the figure. These long slivers of debris typically arise from the edge of the die where the stacked layers of the surface-micromachining process are exposed after sawing. Manipulation of the die with tweezers during the release may have caused the slivers to lie on the combs. Although we didn't observe it here, the slivers are a perfect candidate for shorting between the opposing fingers and the ground plane.

**Figure 7.** Example of debris movement as a result of the vibration. The double tipped arrow indicates the long side vibration direction.

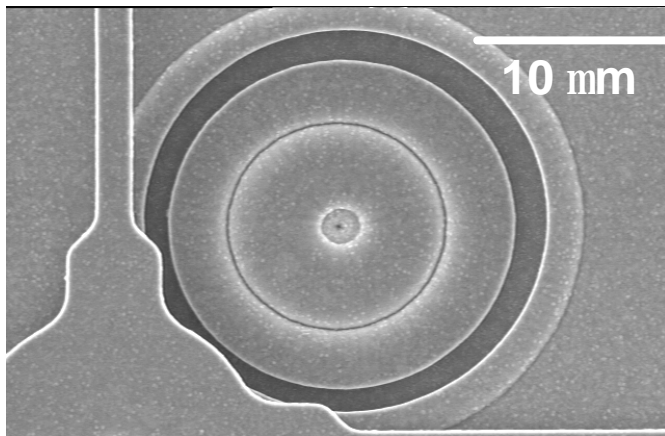
The possibility of producing wear debris from this experiment was also addressed. The regions of the microengine most susceptible to wear were investigated. These regions include the hub and pin joint, spring anchors, and shuttle guides. SEM characterization of these areas did not reveal the presence of wear debris resulting from vibration. As illustrated in figure 8, the hub and pin joint regions do not show the presence of wear debris.

**Figure 8.** Hub and top portion of the pin joint after vibration. Note the lack of wear debris within the hub area and pin joint (lower left).

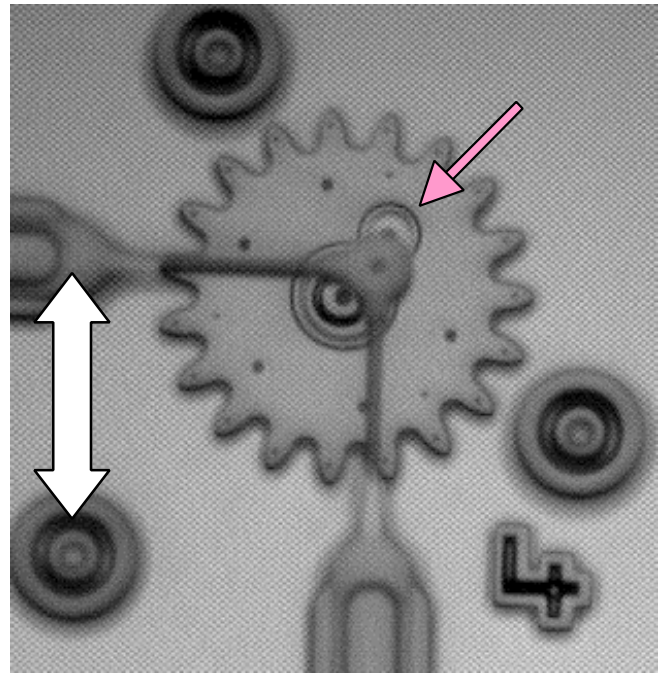
*Broken pin joint failure:* The only microengine failure in the initial test was due to a broken pin joint as seen in Figure 9 with the double-tipped arrow indicating the vibration direction. Our previous observations [16, 17] of broken pin joints were due to wear under accelerated operating conditions, not simple functionality tests. In

**Figure 9.** The linkage arms were disconnected from the gear thereby breaking the pin joint in the region indicated by the arrow. The double-tipped arrow indicates long-side vibration direction.

Was there enough force in this test to shear a pin joint? The polysilicon pin joint has a 2-micron diameter yielding a cross-sectional area of  $3.1 \mu\text{m}^2$ . The force needed to shear the pin can be estimated from  $t = F/A$  where  $t$  is the polysilicon shear strength,  $F$  is the force, and  $A$  is the cross-sectional area. Using maximum-shear-stress theory [18], the shear strength for polysilicon is simply half of the fracture strength which has been measured [19] at 1.5 GPa. Therefore, a force of 2.4 mN would be needed to shear the pin.

We can estimate the forces involved in the vibration assuming that the peak acceleration is 120g. The mass of the moving shuttle, combs, and springs is  $1 \mu\text{g}$ . If we simply use  $F = ma$ , the peak force from the vibration was  $1.2 \mu\text{N}$ , which is clearly over three orders of magnitude lower than necessary for shearing. A typical force used to rotate the microengine is 10 to  $15 \mu\text{N}$  and normal operation does not shear pins. Hence, the peak acceleration due to the vibration was not enough to shear a pin joint,

*Overall failure discussion:* At this point, we are unclear if the vibration caused the pin joint failure. However, it cannot be ruled out. We categorized this failure mechanism as anomalous since it could not be duplicated upon similar experimental conditions. This result indicates that there may have been an initial flaw in the pin joint, or the pin joint suffered some form of damage prior to testing which the vibration acerbated.

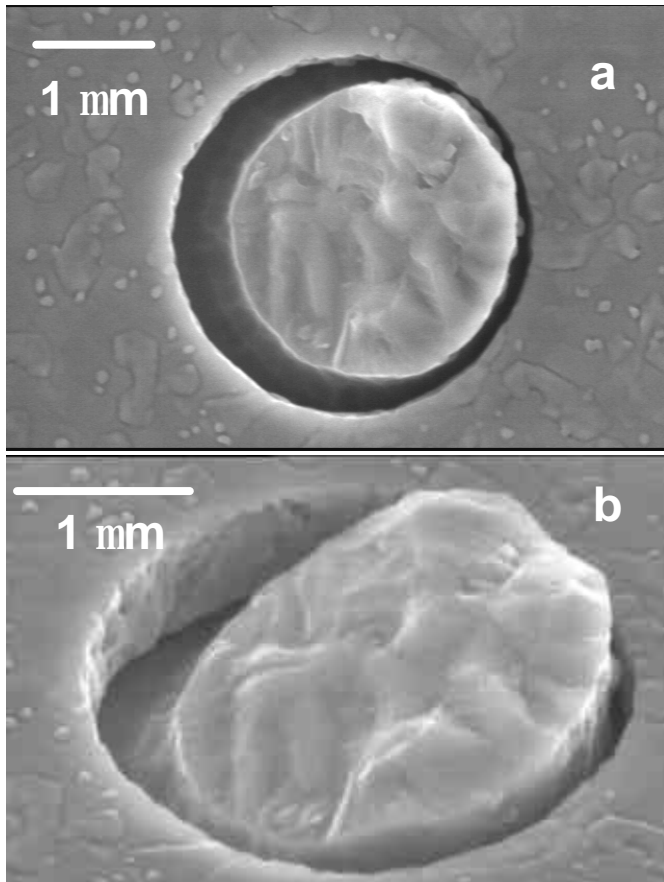
If the pin joint was damaged (crack initiation point) prior to testing, or a processing defect was present in the pin joint region, the vibration could cause crack propagation. Taking a closer look at the severed pin joint using a SEM reveals the fractured surface of the broken pin joint. Figure 10 shows both plan view and tilted characterization ( $40^\circ$  tilt along the z-axis) of the surface. In (b) the image reveals the pin joint fractured diagonal to the ground plane.

When the functionality of the broken-pin-joint microengine was tested, the linkage arms moved over the gear and reconnected to the bottom portion of the pin joint. Once this reconnection was established, the motion of the gear and linkage arms appeared normal at the inspection frequency of 1 Hz. However, running this microengine at high speeds ( $> 500 \text{ Hz}$ ) would disconnect the linkage arms at the broken pin joint again.

**Figure 10.** Plan view (a) and tilted (b) images of the broken pin joint illustrated in Figure 9. Note the fracture surface of the pin joint in (b) is diagonal to the ground plane.

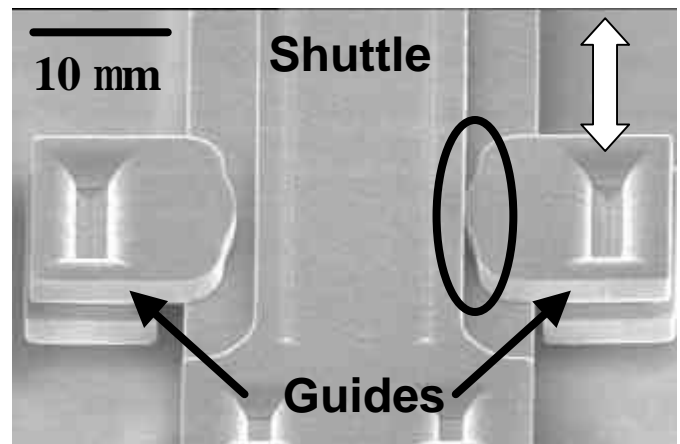
**Adhesion failure:** SEM analysis of the microengine that failed due to adhesion revealed the Y shuttle was stuck to a rear guide near the actuation pads. The rear guides along the x-axis were removed from the device, and the device began to function. However, shortly after functioning, the device went back to its stuck position indicat-

ing that removal of the x-axis back guides momentarily freed up the shuttle but was not the source of the sticking. SEM characterization revealed the sticking site to be the rear guides along the y-axis actuator as illustrated in Figure 11. Note that the shuttle is attached to springs that restore it to the rest (initial) position. The double-tipped arrow in the figure indicates the vibration direction that, in this case, promoted rubbing between the shuttle and the guide. Here the shuttle is deviated to the right, leading to contact along the upper portion of the guide (circled region). Closer examination shows the upper level of the guide in contact with the top portion of the shuttle. No debris could be found near the failure region, indicating it is an adhesion failure and not a failure resulting from impact debris.

**Figure 11.** Adhesion failure sight in a microengine.

The adhesion failure was vibration related. The direction of the vibration promoted the rubbing of the moving shuttle and the guide. We suspect that the rubbing caused the adhesion.

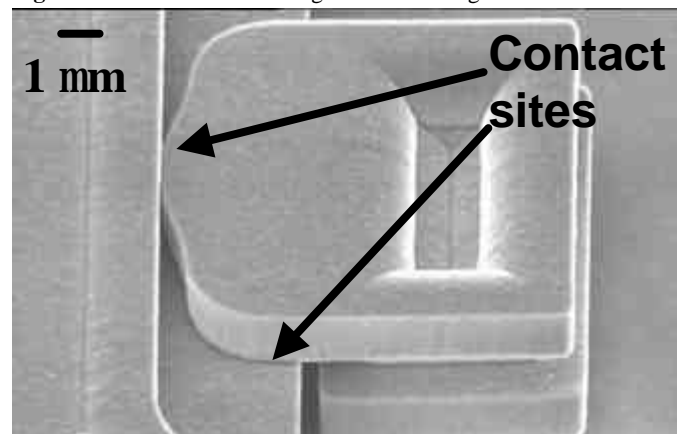
It is also interesting to note that the shuttle appears to be elevated from its initial position even though the restoring springs are attempting to pull it down. Further characterization into this area reveals the top portion of the shuttle is contacting the bottom overhanging part of the guide as revealed in Figure 12. Although the failure site has been characterized, the reason for the shuttle lifting and contacting the bottom portion of the overhanging guide is not known at this time.

**Figure 12.** Close up image of the adhered region of the microengine.

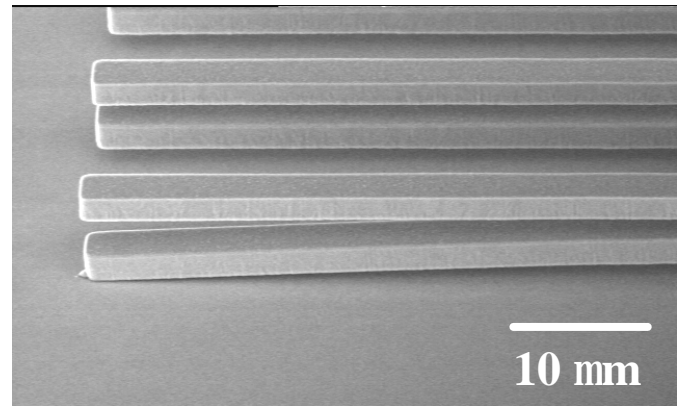
Investigating the electrical short failure using a SEM revealed a polysilicon comb finger adhered to the polysilicon ground plane as shown in Figure 15. Although this failure may appear to be “stiction” related, it is not. Stiction-related failures occur predominantly during the release process. These microengines were released and characterized both optically and electrically. Both inspections did not reveal the presence of adhered comb fingers. This indicates the comb finger somehow adhered to the ground plane to induce failure after the initial inspection.

**Figure 15.** Polysilicon comb finger adhered to the ground plane.

Because the three electrical short failures in the repeat test were duplicated in the controls, we can assume that they were not due to vibration.

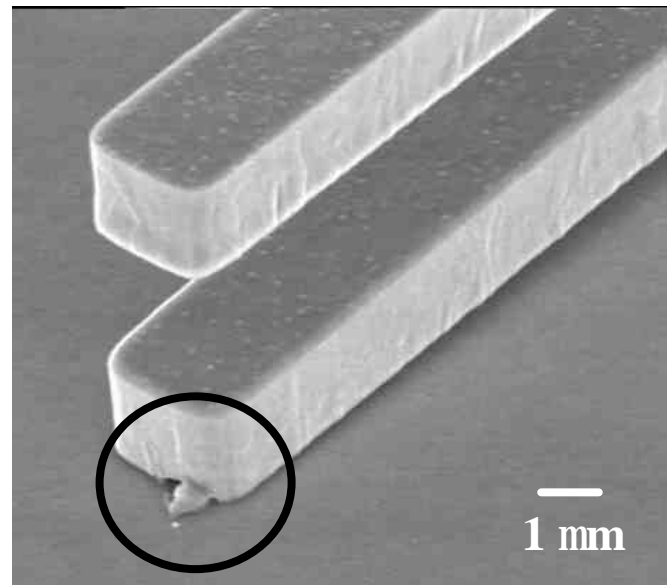
Upon further SEM inspection, residual material is present at the tip of the comb finger as illustrated in Figure 16. Characterization and experiments are currently underway to determine if the material is a result of particular contamination, residue along the comb finger,

or arcing due to electrostatic discharge (ESD). In either case, the direct result is a short of a bottom comb finger to the ground plane.

**Figure 16.** Close up SEM image of the adhered comb finger of Figure 15. Residual material is present at the tip of the comb finger (depicted in the circled region).

In our vibration stress tests at four times the level of our typical system requirement, we observed a 90% success with only 2 failures out of 19 tested. The vibration spectrum had a peak acceleration of 120g and was equivalent to roughly  $5 \times 10^5$  oscillations but it produced no wear debris along the rubbing or impacting surfaces in the microengines. Movement of slivers of debris was observed, but it caused no failures. However, the potential for failure exists where a piece of debris can bridge the gap between the comb drive and ground plane resulting in a direct short. Steps should be taken to eliminate the debris.
